#### HARWORTH HEATING LIMITED

# **TECHNICAL INFORMATION**

Samson Stat.used on 1 to 3 series appliances

SHEET REF > Samson.CHP D1 020290

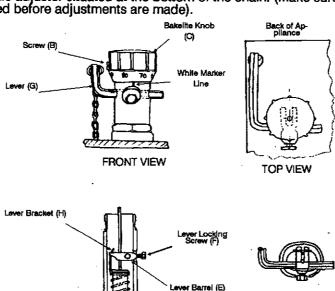
SECTION TOP VIEW

- 9. Refit the new cartridge assembly making sure that the lever bracket "H" is placed facing the hole through which the barrel lever will be inserted (See SECTION TOP VIEW)

- 10. Using considerable pressure against the spring screw on the bakelite knob "C" until the lever bracket "H" is low enough to allow you to slip the lever barrel "E" into place, and then refit the lever "G" back into its original place securing it with the lever locking screw "F".

5. Remove the brass screw "B". (See FRONT VIEW)

- 6. Loosen the lever locking screw "F" and withdraw the lever "G", taking care to remember which side the bend in the lever is on (See  $\,$  TOP VIEW  $\,$ )

- 7. Remove the knob "C" and pull out the lever barrel "E". NOTE If screw "B" is not unscrewed enough, damage to the multistart thread can occur.
- 8. Remove the old cartridge assembly "F" (See SIDE VIEW)
